PRELIMINARY ASSESSMENT

METLAKATLA PENINSULA

Prepared for
Metlakatla Indian Community

Prepared by
Ridolfi Engineers and Associates, Inc.
Seattle, Washington

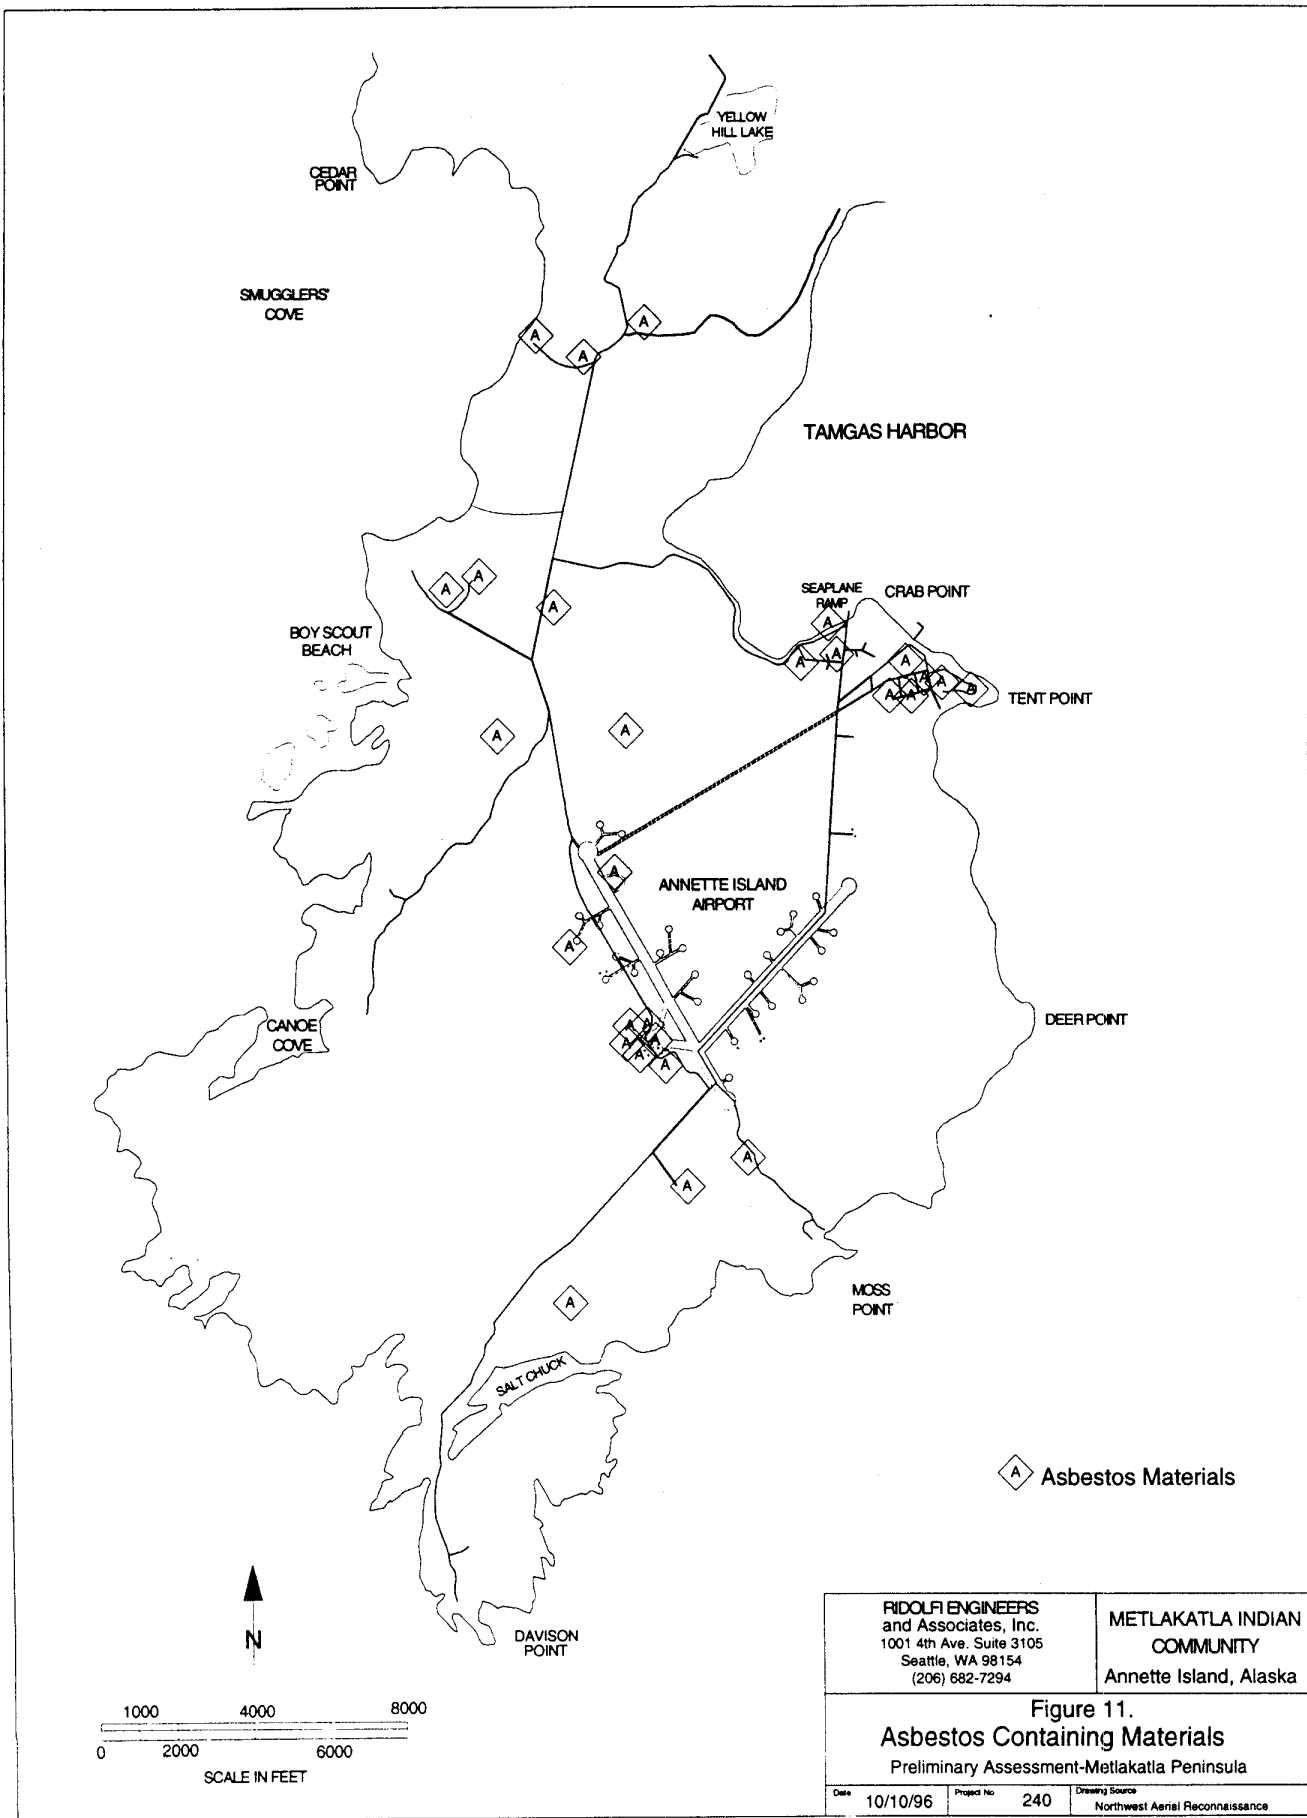
A previous environmental investigation confirmed the presence of asbestos in thermal insulation from a steam boiler. ACM such as thermal insulation, exterior and interior siding, roofing material, and vinyl flooring is suspected to have been used in the many of the existing DOD and FAA buildings and communication/navigation facilities. Refer to Figure 11 for the locations of concern for ACM.

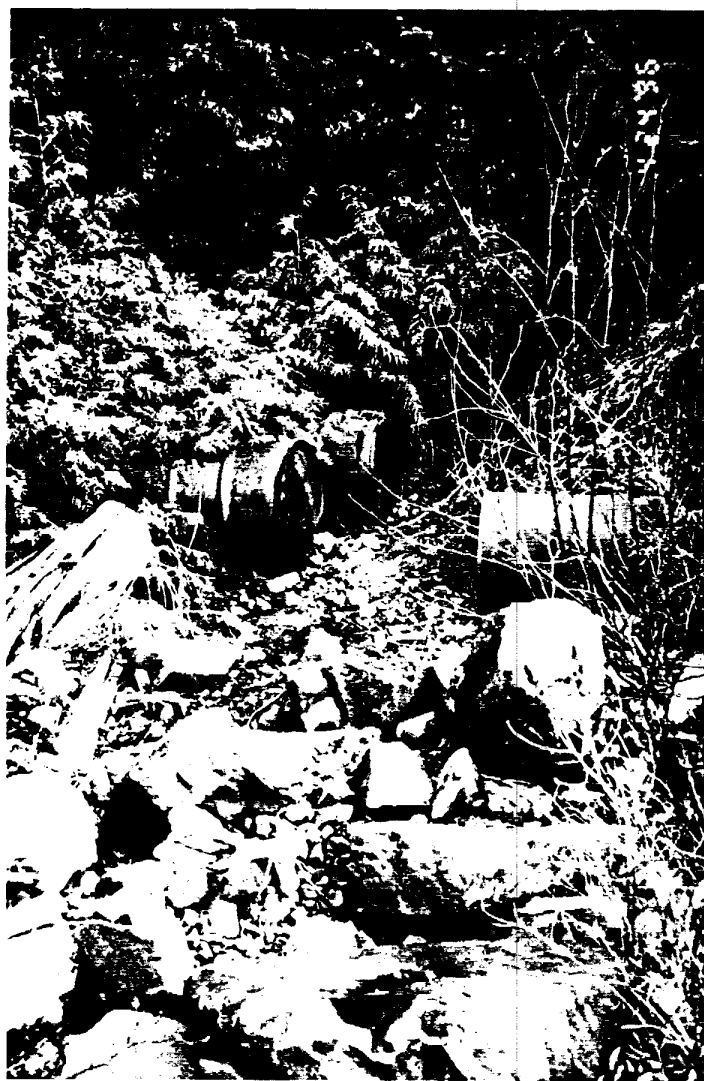
Photograph 24a: Middle Marker Facility

The remains of the middle marker facility consist of an 8-foot x 12-foot white wood frame building (see photograph 24a). The building contains abandoned electronic equipment and vinyl tile flooring.

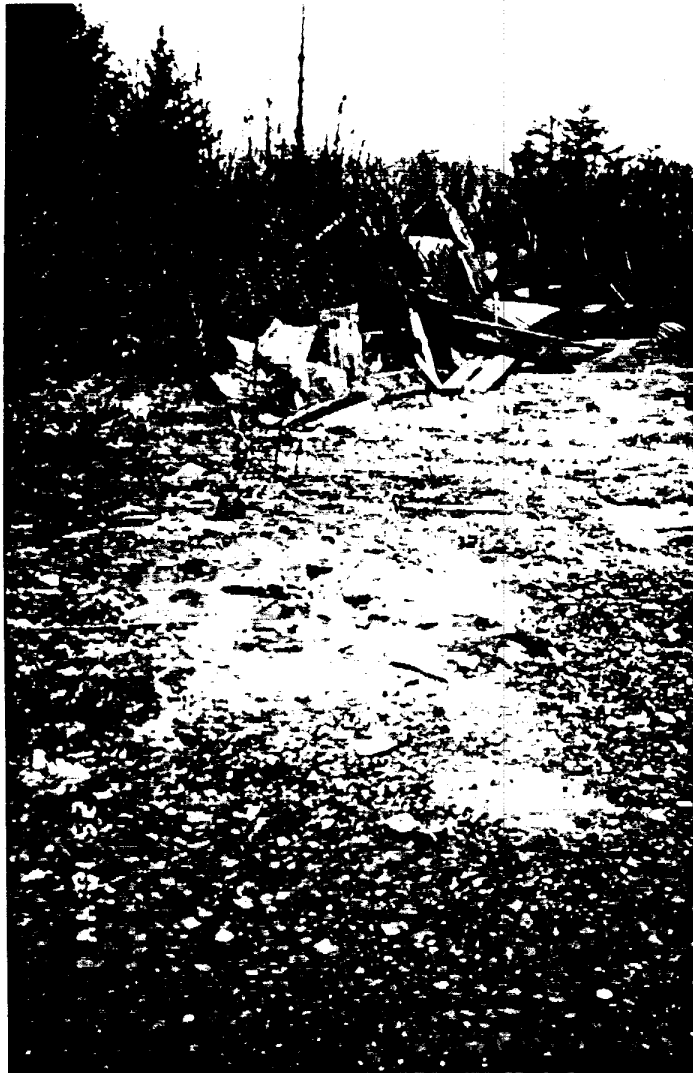
Photograph 37a: Sand Shed/Asphalt Plant

The remains of the FAA metal sand shed consist of charred wood debris, metal, and remnants of a sand pile (see photograph 37a). Sand was imported and used on the runways during icy winter conditions (Dunne, 1996). No asphalt plant building exists although a layer of tar covers the surface of the ground around the former site of the sand shed (see photograph 37b and photograph 37c). Several 55-gallon barrels were

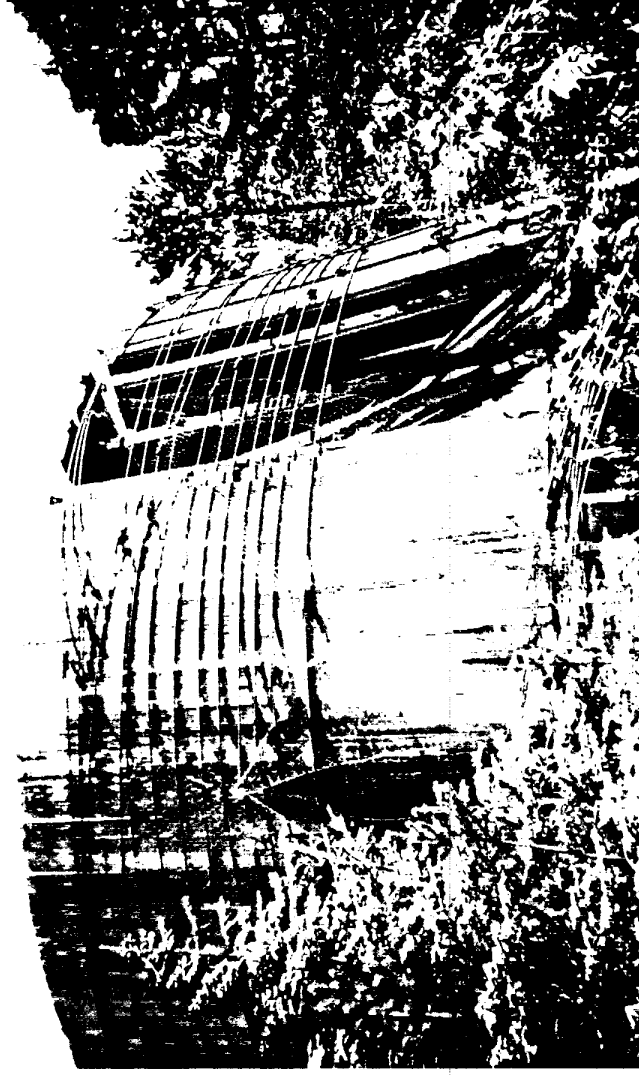
Photograph 39b: Fuel Pipeline System

The remains of wood platforms were observed, but all ten ASTs along the coastline have been removed. The 7,000-gallon tank is present on a wood platform (see photograph 39b). Two of the 80,000 gallon tanks (eastern and western tanks) have been dismantled leaving only their foundation, but the third tank is intact (see photograph 39c). A petroleum odor is prominent at all three tank sites. The eastern and western tank sites exhibit zones of distressed vegetation (see photograph 39d), and the most western tank site exhibits a petroleum sheen on pooled water near the tank's foundation and in disturbed bottom sediments in an adjacent flowing stream. The fifteen 50,000 gallon tanks have been removed although concrete saddles and associated tank/pipe connection boxes mark their former locations (see photograph 39e). The five 50,000 gallon underground storage tanks remain in place. A concrete vault is positioned over each of the USTs (see photograph 39f). One fueling pit is located at the north end of the main runway. Other fueling pits may exist near the hangar, but are obscured by cut lumber or wood debris generated by the hangar sawmill operation.

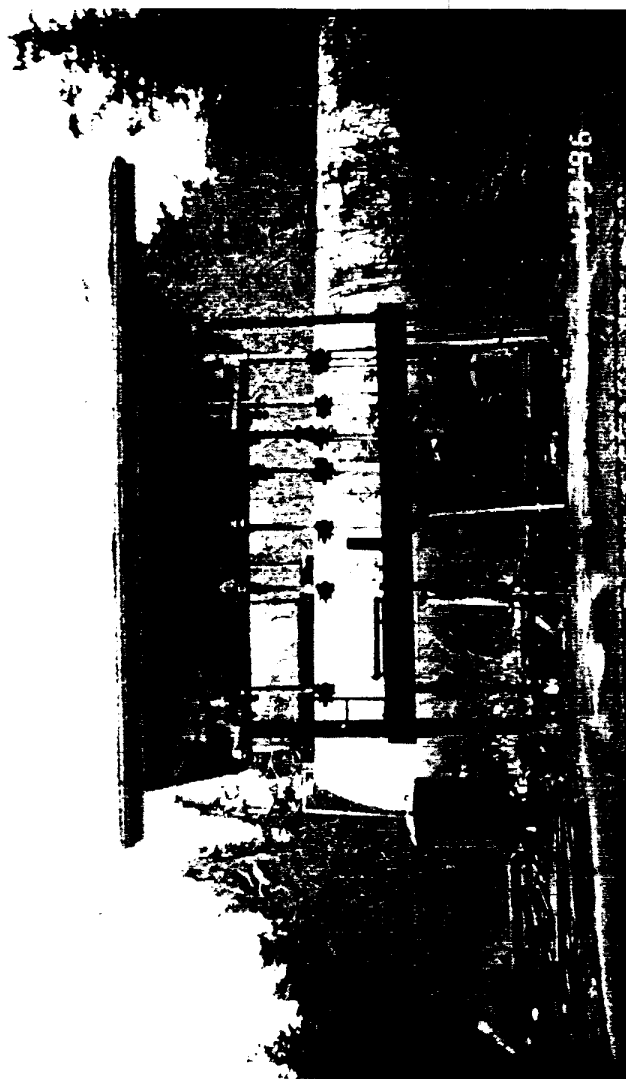
Photograph 42a: FAA Tank Farm

The FAA tank farm is an unbermed area of approximately 100 feet x 100 feet. The remains of the tank farm consist of a truck tanker fuel loading dock (see photograph 42a), seven 50,000 gallon ASTs (see photograph 42b), two 25,000-gallon ASTs, one 12,000-gallon AST, three 10,000-gallon ASTs (all labeled "Chevron") and associated pipelines. A cleared area approximately 75 feet wide immediately west of the 50,000-gallon ASTs contained an additional eight 50,000-gallon ASTs, which were moved to the electric generating plant in Metlakatla in the late 1980s (Dunne, 1996). Soil in the tank farm area is stained and has a strong petroleum odor. Petroleum sheens were observed on ponded water, and in the tank farm area, and emanating from some tank farm piping.

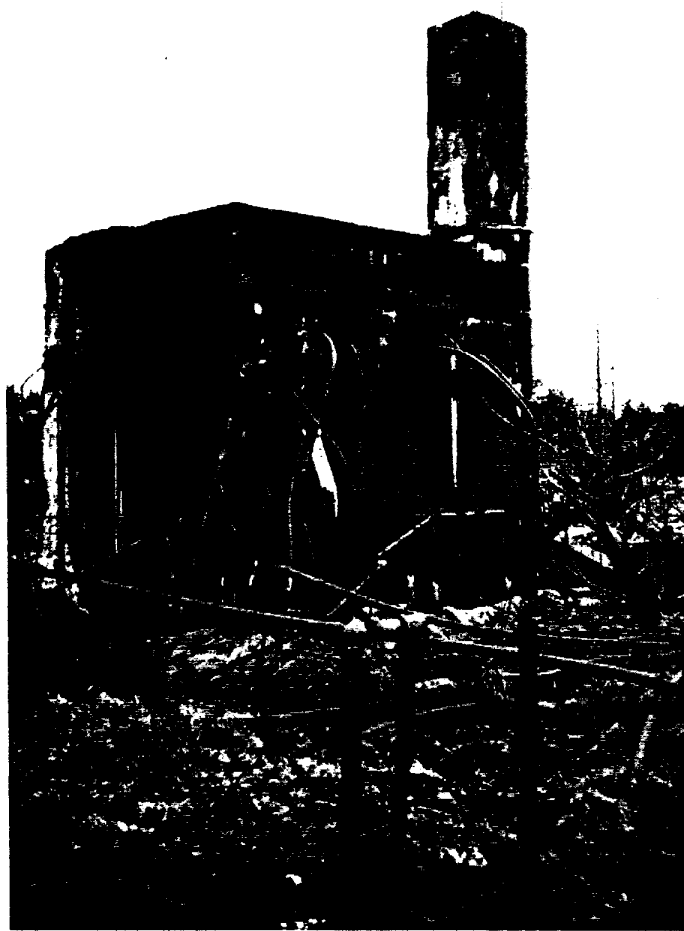
Photograph 54a: Public School

The remains of the public school consist of a "z"-shaped concrete foundation, a small concrete boiler room (see photograph 54a), metal piping, metal structural steel, and metal building debris. The boiler room contains an insulated boiler and insulated piping. The debris contains vinyl floor tile, another insulated boiler, and pipe insulation (see photograph 54b).

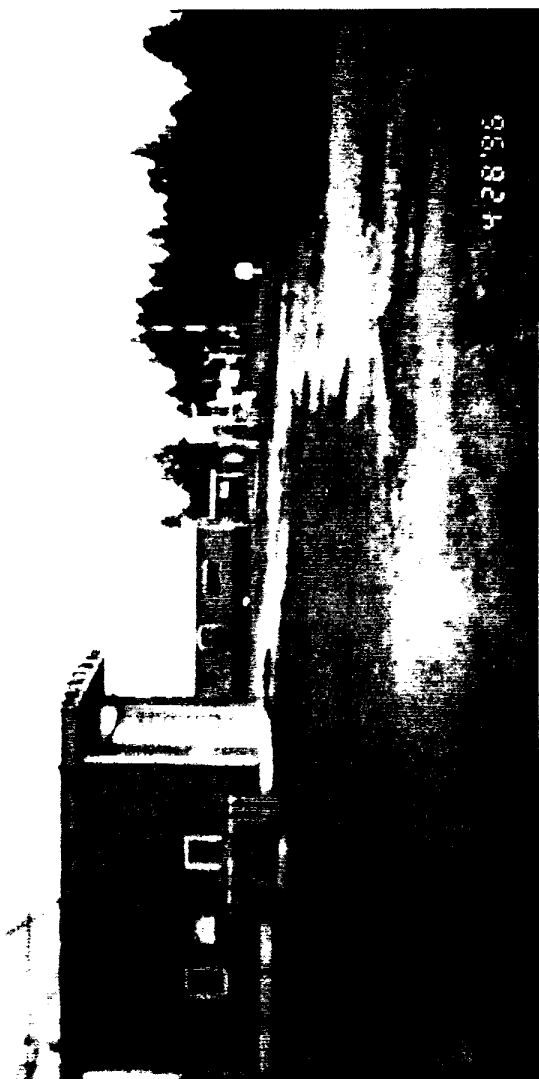
Photograph 67a: Weather Bureau Station

The weather station contains two structures: a 20-foot x 30-foot single story, wood frame office building and a 20-foot x 20-foot, domed, wood frame weather balloon release building. An instrument gauging area is located between the two buildings (see photograph 67a). The office has a heating-oil AST adjacent to the west side of the building.

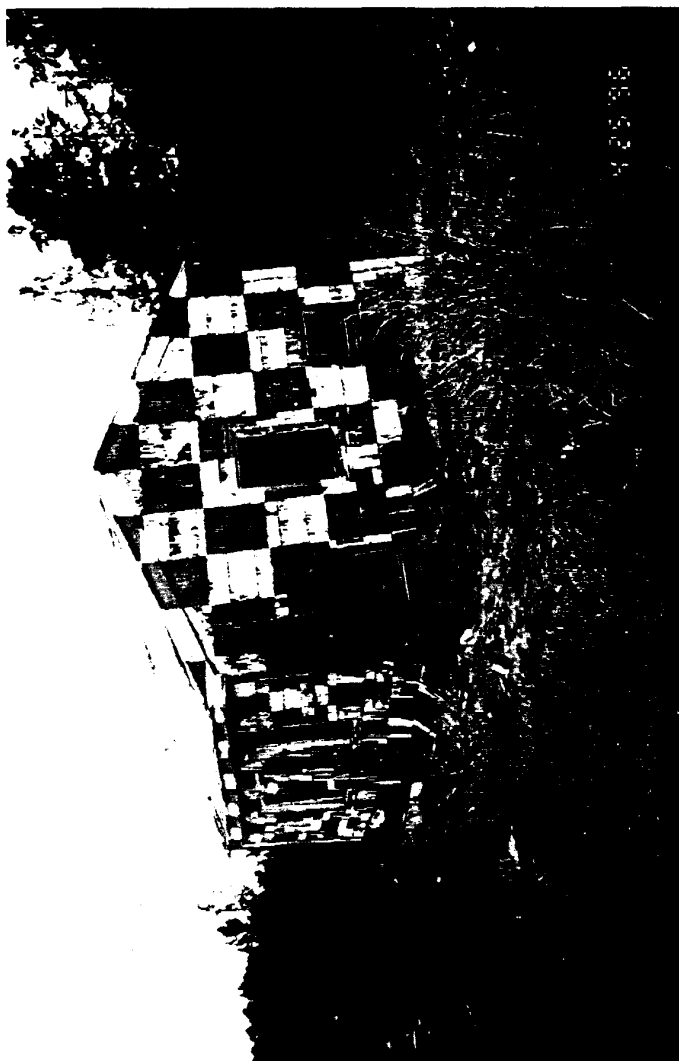
Photograph 80a: Localizer

The remains of the localizer consist of a 12-foot x 18-foot orange and white wood frame building (see photograph 80a). The facility was constructed in 1952 (St. John, 1992) and contains abandoned electronic equipment, and vinyl tile flooring.

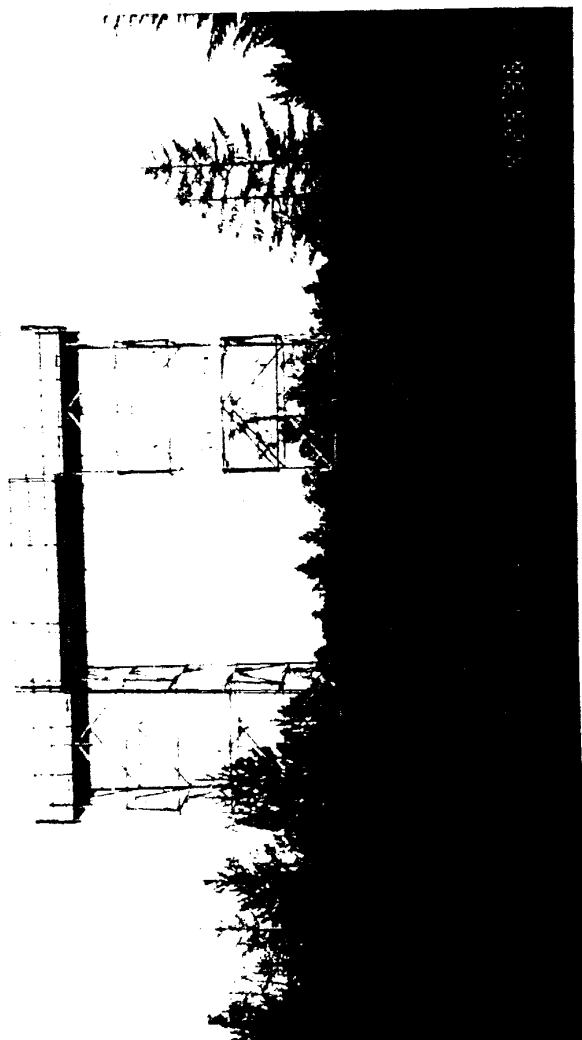
Photograph 80b: Localizer

The remains of a 60-foot wide orange steel tower was located 300 feet east of the localizer (see photograph 80b).
